Near grounding of *Rosco Poplar*

Bond Reef, Hydrographers Passage, Queensland on 4 May 2022

ATSB Transport Safety Report

MO-2022-005

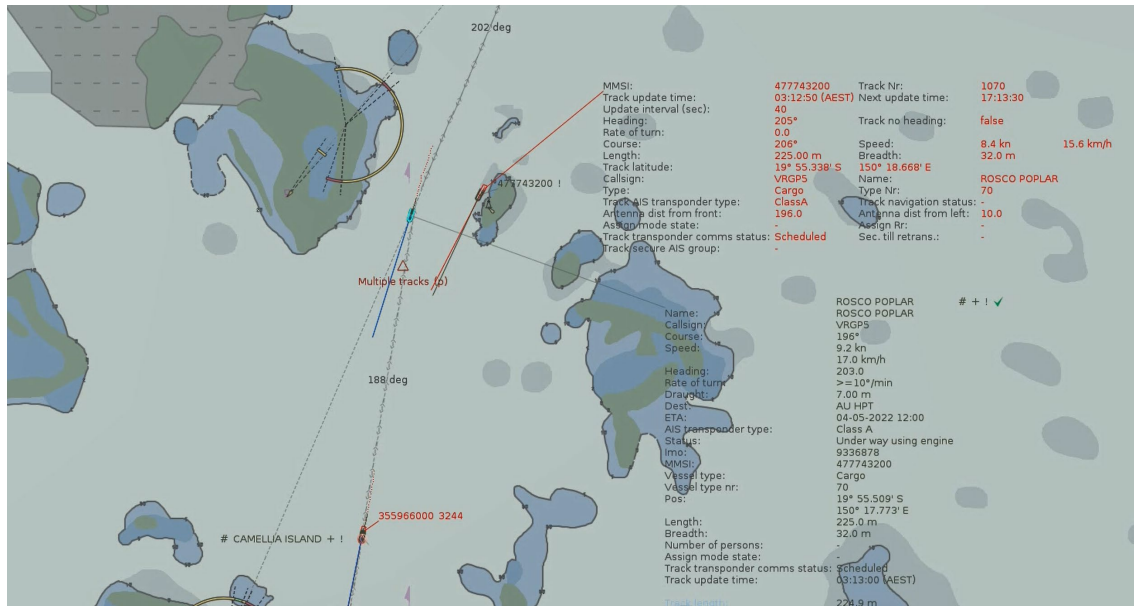
Figure 6: Rosco Poplar's track information at 0313, as displayed at REEFVTS

Meanwhile, at 0313 a series of alerts, including a potential grounding alert, were generated by the REEFVTS decision support tool (DST)⁷. The duty vessel traffic service operator (VTSO) noted that these alerts were associated with multiple dead reckoning (DR) targets for *Rosco Poplar* (Figure 6). The VTSO assumed this was due to a DST system error. The VTSO checked the ship's displayed position and track to determine if intervention was required.

At 0313, the VTSO noted that the ship's position had suddenly shifted close to Bond Reef, after which it had started tracking away from the reef. The VTSO decided against calling the pilot/ship's crew and began investigating the suspected DST system error. From about 0321, the VTSO made several internal calls to Gladstone VTS and others, which seemed to confirm a possible system error. At 0330, the VTSO started calling the ship (on VHF channel 11) but could not establish contact until 0336 (on VHF channel 14). In the subsequent discussion with the pilot, it was confirmed that the ship had in fact passed close to Bond Reef.

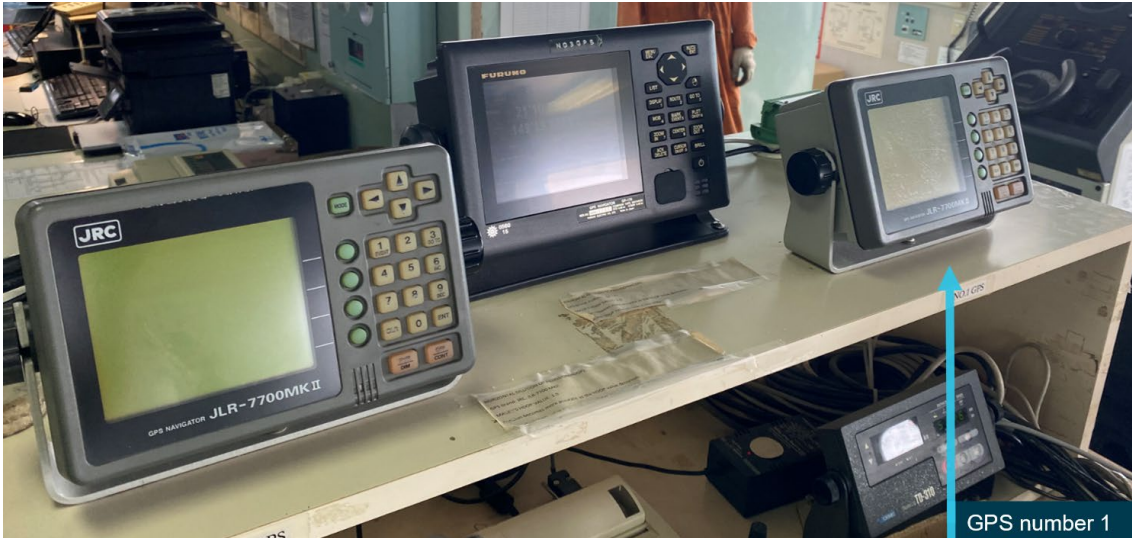
Figure 9: Arrangement of the GPS units

The master and second mate both reported that 'GPS 1' was selected during the pilotage, this being one of the JRC units (Figure 9). Due to the location of the 3-way switch, files obtained from the VDR and ECDIS following the occurrence were unable to provide GPS source information necessary for confirming which of the 3 GPS units was selected during the pilotage.

The JRC units consisted of a JLR 7700MKII differential GPS, paired with a JLR 4331 differential GPS-capable antenna. The manufacture of both the GPS and antenna were discontinued in 2012, and with spare parts no longer available for some time before the occurrence, were considered obsolete. In January 2022, the ship's management company decided to replace the JRC units during the ship's call at Hay Point.

The GPS units' manufacturer, JRC, advised that the likely cause of the error was an internal failure related to the antenna of the selected GPS unit. From the time the GPS unit began to malfunction until 0312:15, when the GPS position was lost, the unit continued to send processed data of invalid position, without updating the accuracy information. Hence, the invalid position data did not generate any positional error alerts on the GPS unit, which would also have triggered alerts on connected navigational aids. It was not until the GPS position was lost that the ECDIS units started displaying that the GPS unit had regressed to dead reckoning mode (to indicate that it had reverted to estimating position based on the ship's heading and log speed). The exact reason why the GPS unit did not detect the positional error could not be determined due to the limited available data.

While in Australia, the ship's bridge navigational system was updated by shore technicians with new GPS units and a reconfigured wiring system to interconnect the electronic navigational aids. The update facilitated multiple GPS inputs for the different aids, providing greater redundancy in the event of single GPS unit failures.

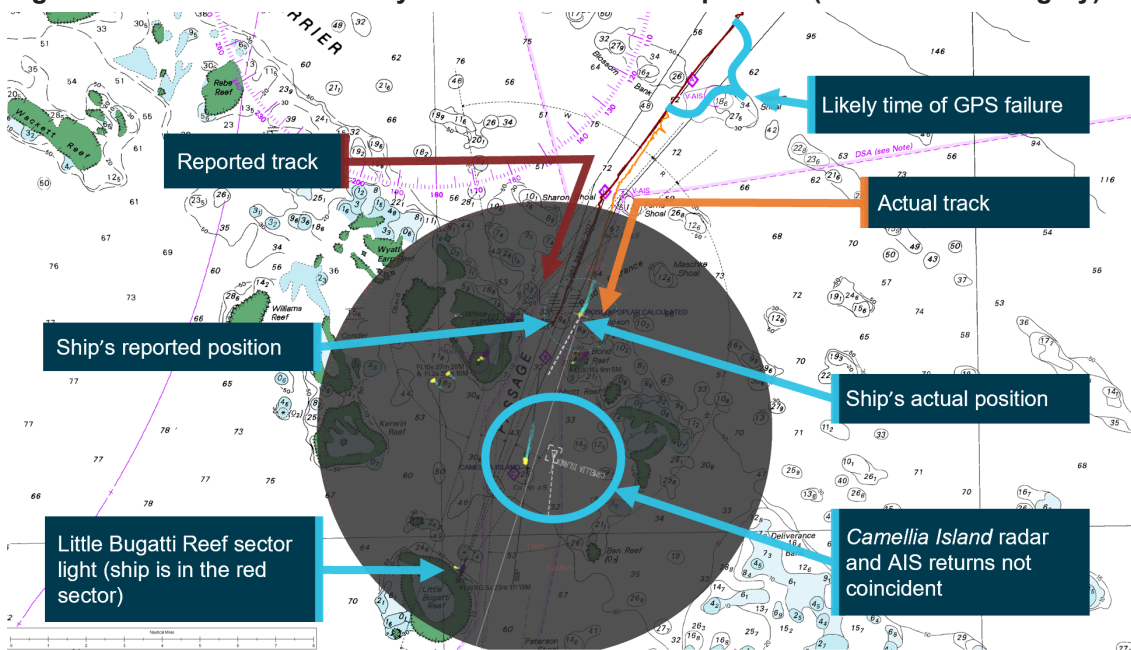
Figure 12: Position indicated by GPS at 0305 vs actual position (radar overlaid in grey)

Following the occurrence, the ATSB reconstructed *Rosco Poplar's* actual track during the approach to Bond Reef using the ship's x-band radar display images recorded by the VDR with corresponding navigational chart features in the vicinity (Figure 12).

From the approximate time at which the GPS unit began providing inaccurate positional data, until the loss of GPS signal altogether at 0312:15, the ship's actual position deviated approximately 0.92 miles (1,704 m) from the position indicated by its GPS. The invalid position placed the ship on the planned 202° (T) track rather than indicating its actual position, with the deviation gradually increasing over this period as the ship actually made good a course of approximately 195° (T) (Table 1).

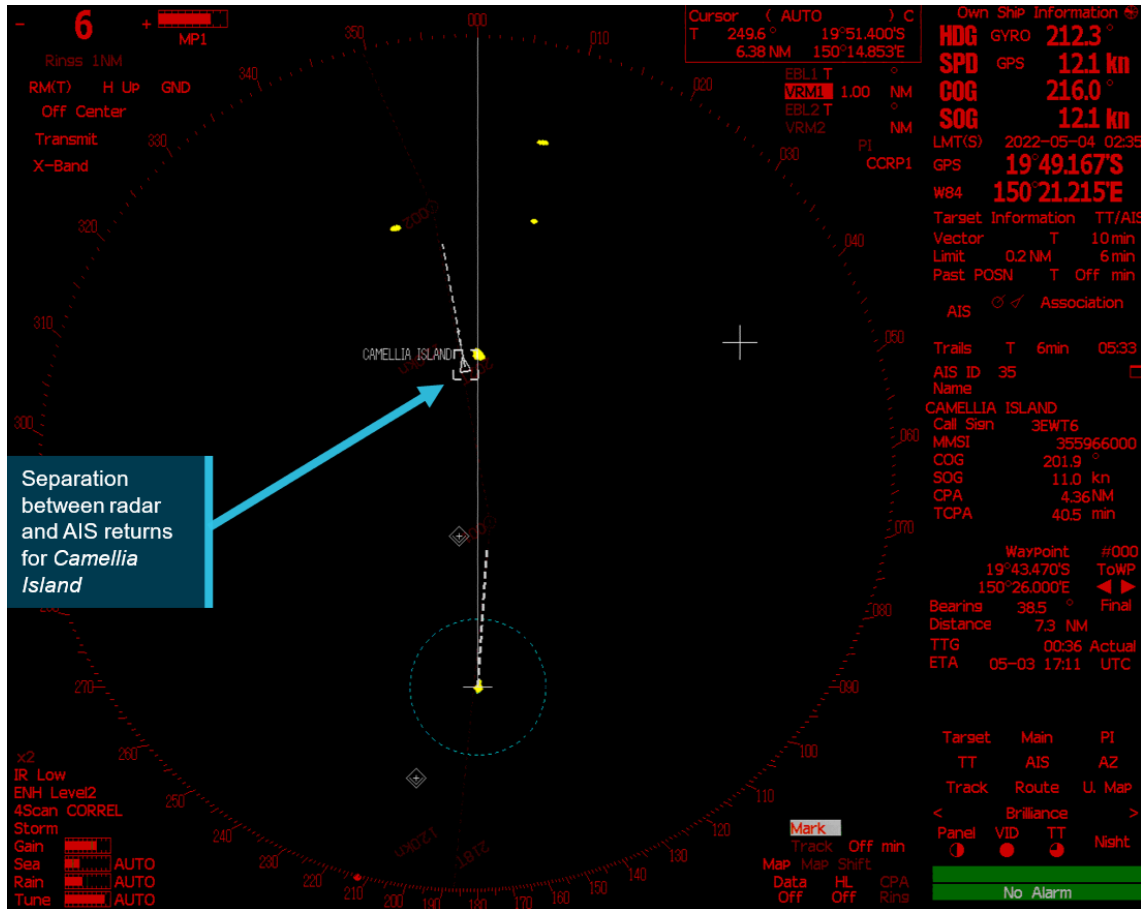
Figure 13: Radar image at 0235

Following the completion of the waypoint input, and returning the radar to active mode, the radar image captured at 0234:52 showed a separation of *Camellia Island's* radar return from its reported AIS position, indicating that the selected GPS unit was no longer providing an accurate position (Figure 13). This separation gradually increased and the ship began to deviate from the planned route towards Bond Reef beacon (visible on the radar display) as the pilot's heading orders were based on the erroneous position and track displayed on the ECDIS and PPU. Assessment of the ship's reconstructed actual track indicates that by about 0256, it had deviated far enough from its planned track to be within the red zone of Little Bugatti reef sector light ahead.

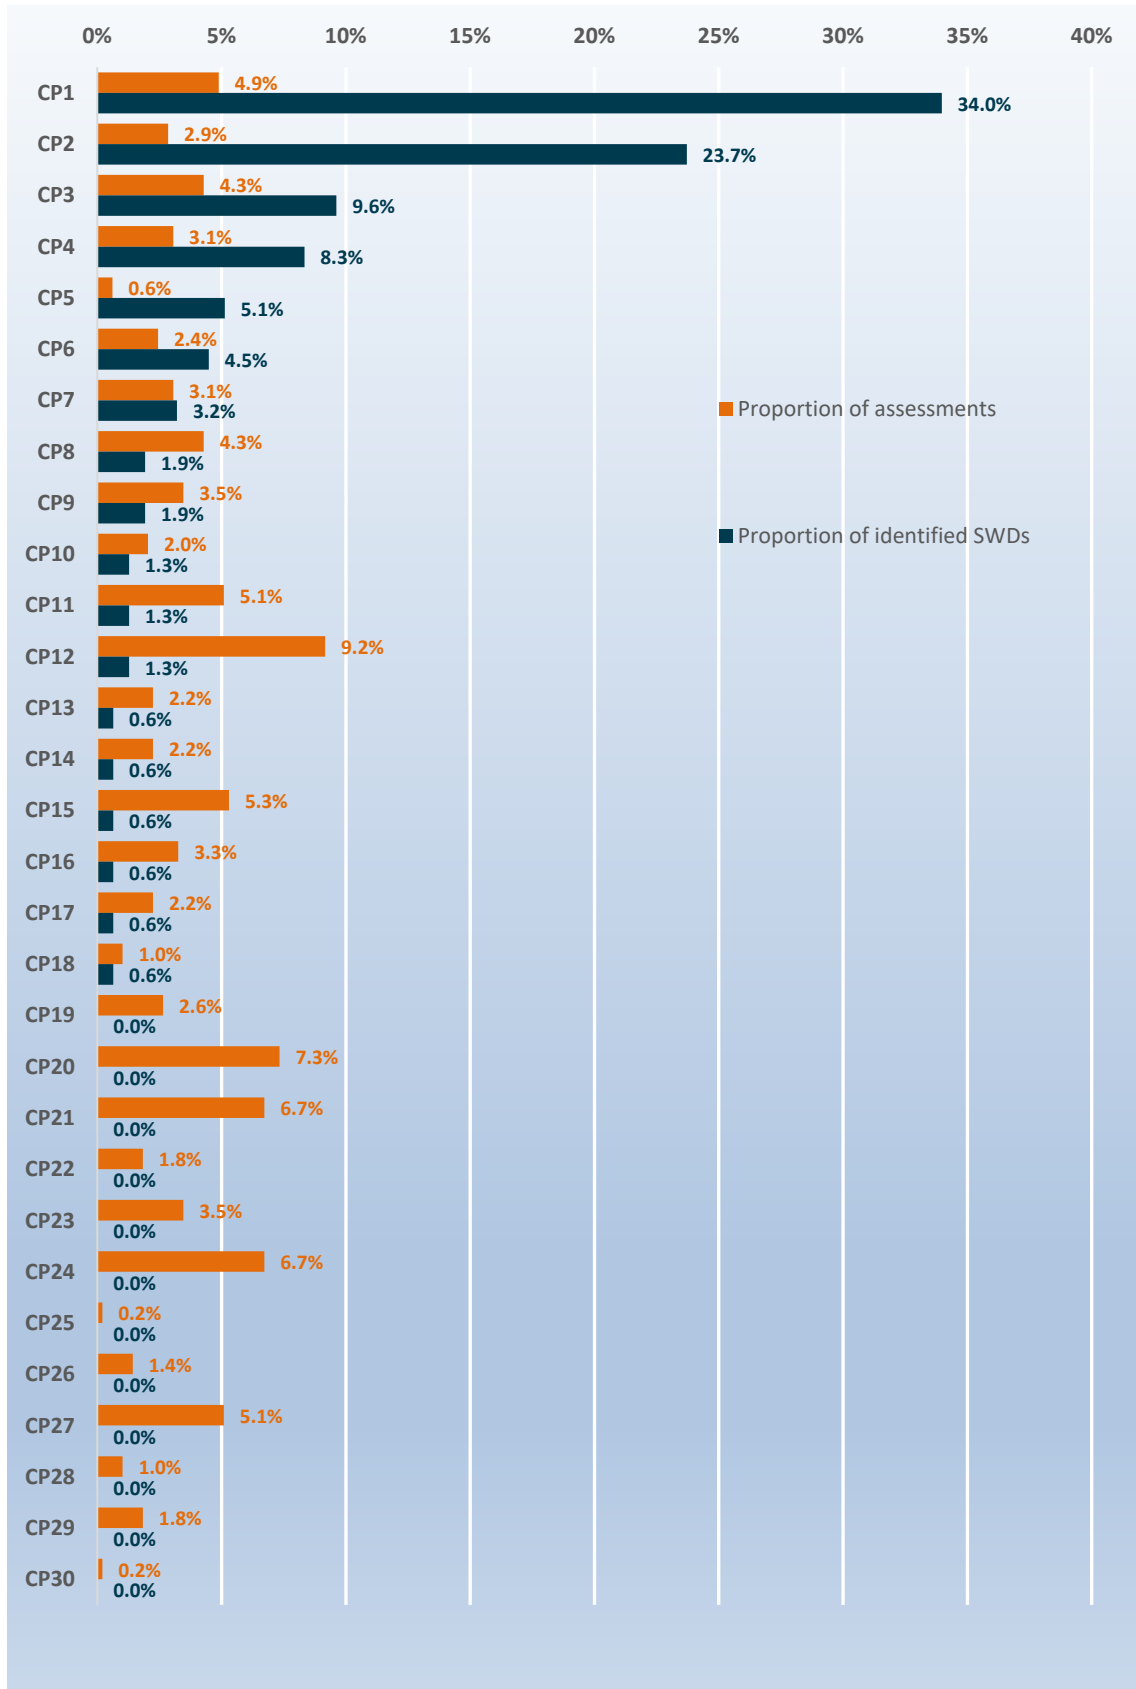
Figure 16: Proportion of deficiencies identified by each check pilot

- Two (2) check pilots (from different pilotage providers) conducted 7.7% of the total number of assessments and accounted for 58% of the total deficiencies identified.
- Eight (8) check pilots conducted 25% of the total number of assessments and accounted for 90% of the total deficiencies identified
- Twelve (12) check pilots conducted 32% of the total number of assessments and never identified any deficiencies

The ATSB applied the Kruskal-Wallis⁴⁶ test to the data to determine whether there was a statistically significant difference between the application of assessments between individual check pilots. This test showed that the probability of obtaining the distribution of such assessment results by random chance alone would be less than 1 in 10,000. That is, the distribution was likely influenced by differences in how individual check pilots conducted their assessments.

The ATSB issued a safety recommendation to AMSA to address factors limiting the effectiveness of its check pilot framework as a system for coastal pilot competency assurance.
