National Transportation Safety Board

DCA24MM031

VOYAGE DATA RECORDER (VDR) AND OTHER ELECTRONIC DATA

Group Chair's Factual Report

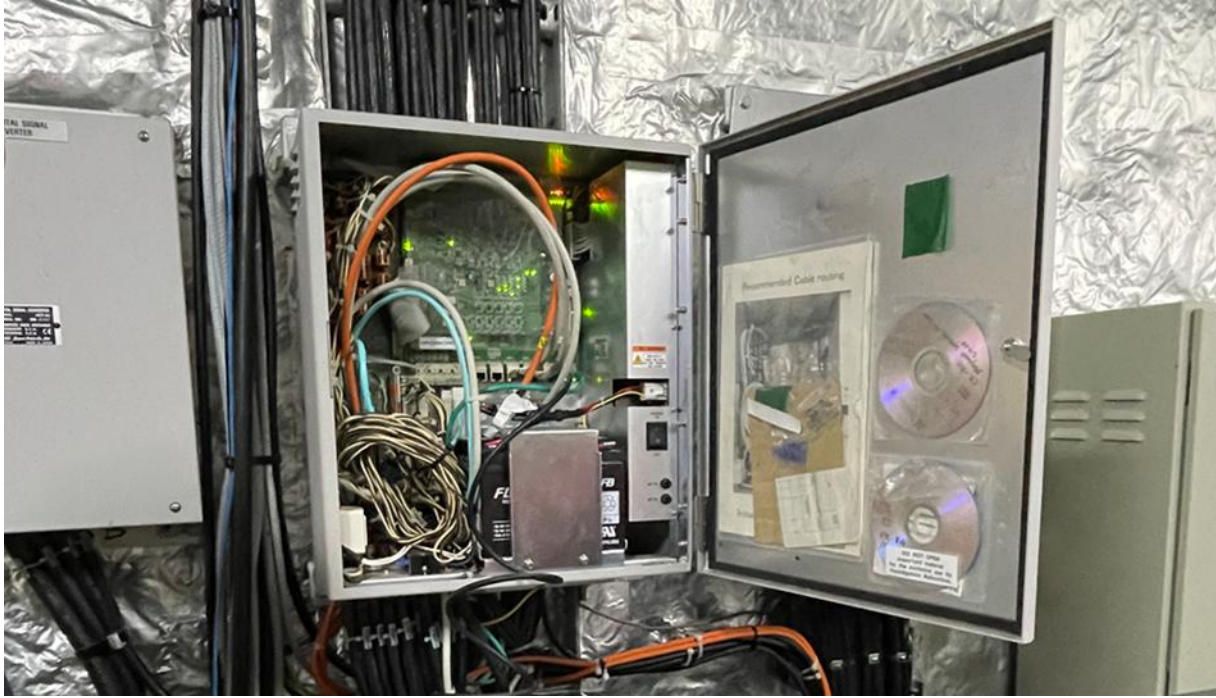
Figure 2. Photo of VDR cabinet mounted in an electrical room below the bridge on the *Dali*.

In order to access VDR data, raw VDR data were downloaded from the ship's VDR. This can be accomplished in two ways, one, using the JRC JCY-1900's bridge mounted USB VDR console, or using an ethernet connection to the VDR cabinet mounted below the bridge (see Figure 6 and Figure 2, respectively).⁵

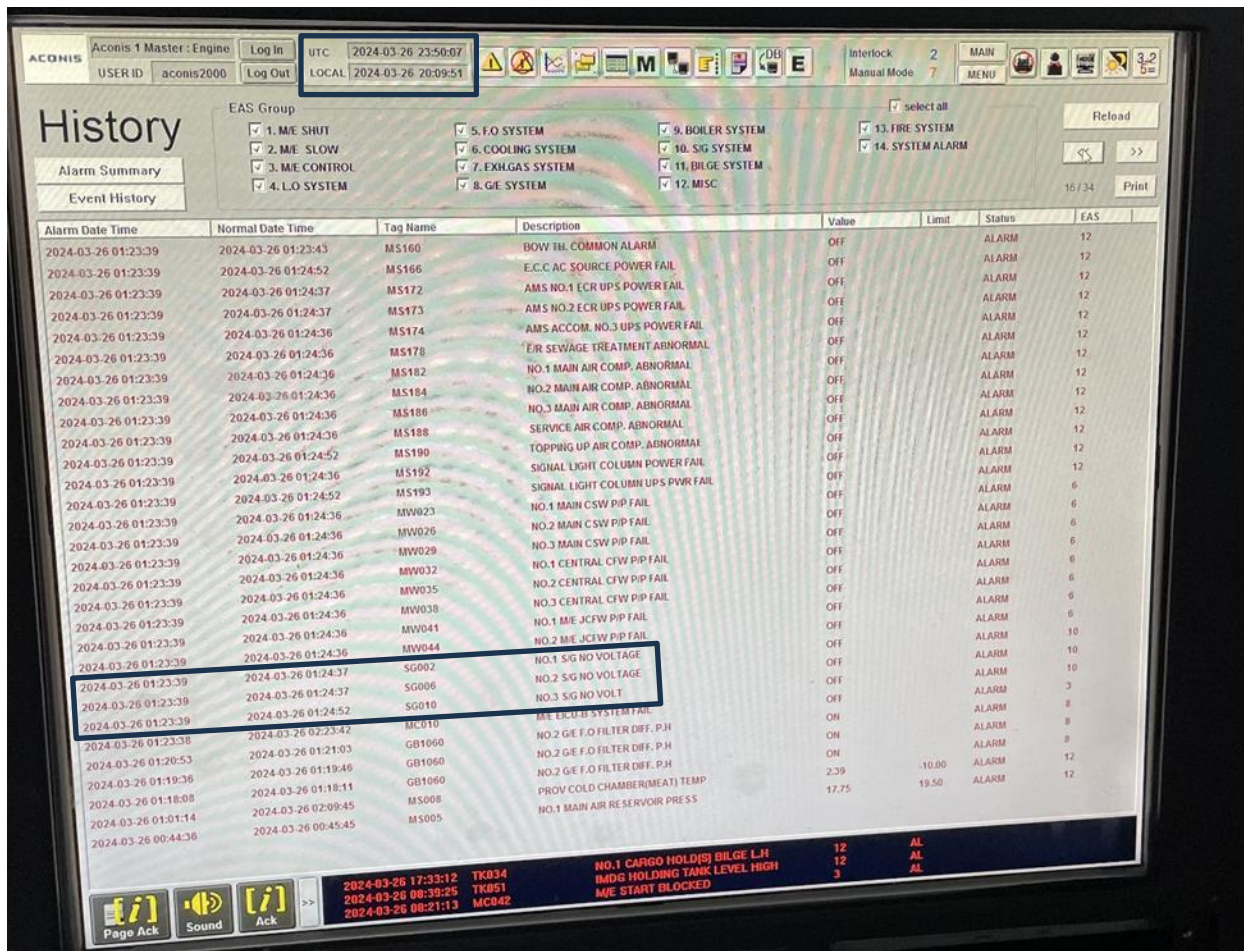
Figure 11. ACONIS panel showing steering pump voltage alarms (annotated) and the timestamps.

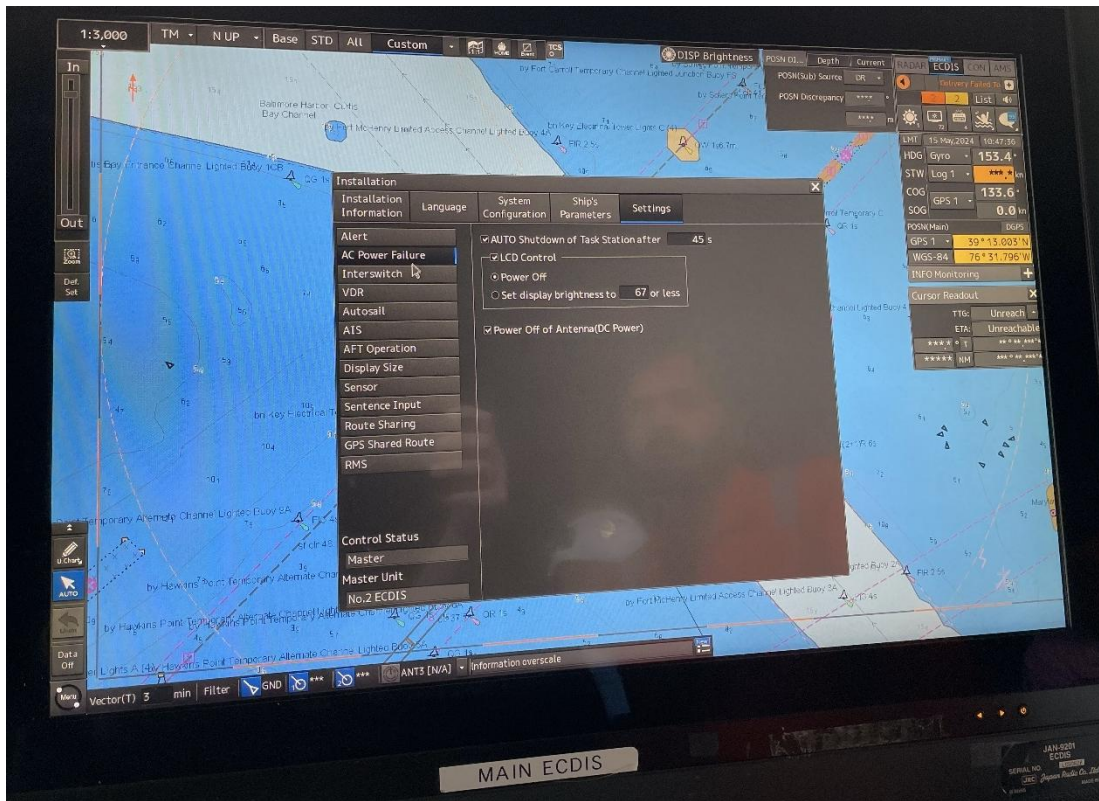
Figure 13. Photo of Main ECDIS AC power failure settings (crewmember reflection redacted).

During a loss of ship's AC power, the MFD units are designed to power from a battery backup. The battery power source is located under each MFD module. JRC supplied a test procedure to verify the MFD display settings during a simulated blackout condition. In the MFD installation menu, an option can be configured to either turn the MFD display off, or to dim the display in the event of the loss of ship power while on the operation of the MFD backup battery. Post accident testing on May 15, 2024, showed four of the five displays were configured to power off the MFD LCD display during an AC power failure event (see Figure 13). Additionally, the MFD cabinets were inspected for the presence of an MFD backup battery as well as the battery's functionality. Each MFD console contained a backup battery, however, it was determined that a voltage measurement of each battery would not be representative of the condition of the batteries during the accident event, since 50 days had passed since the event.

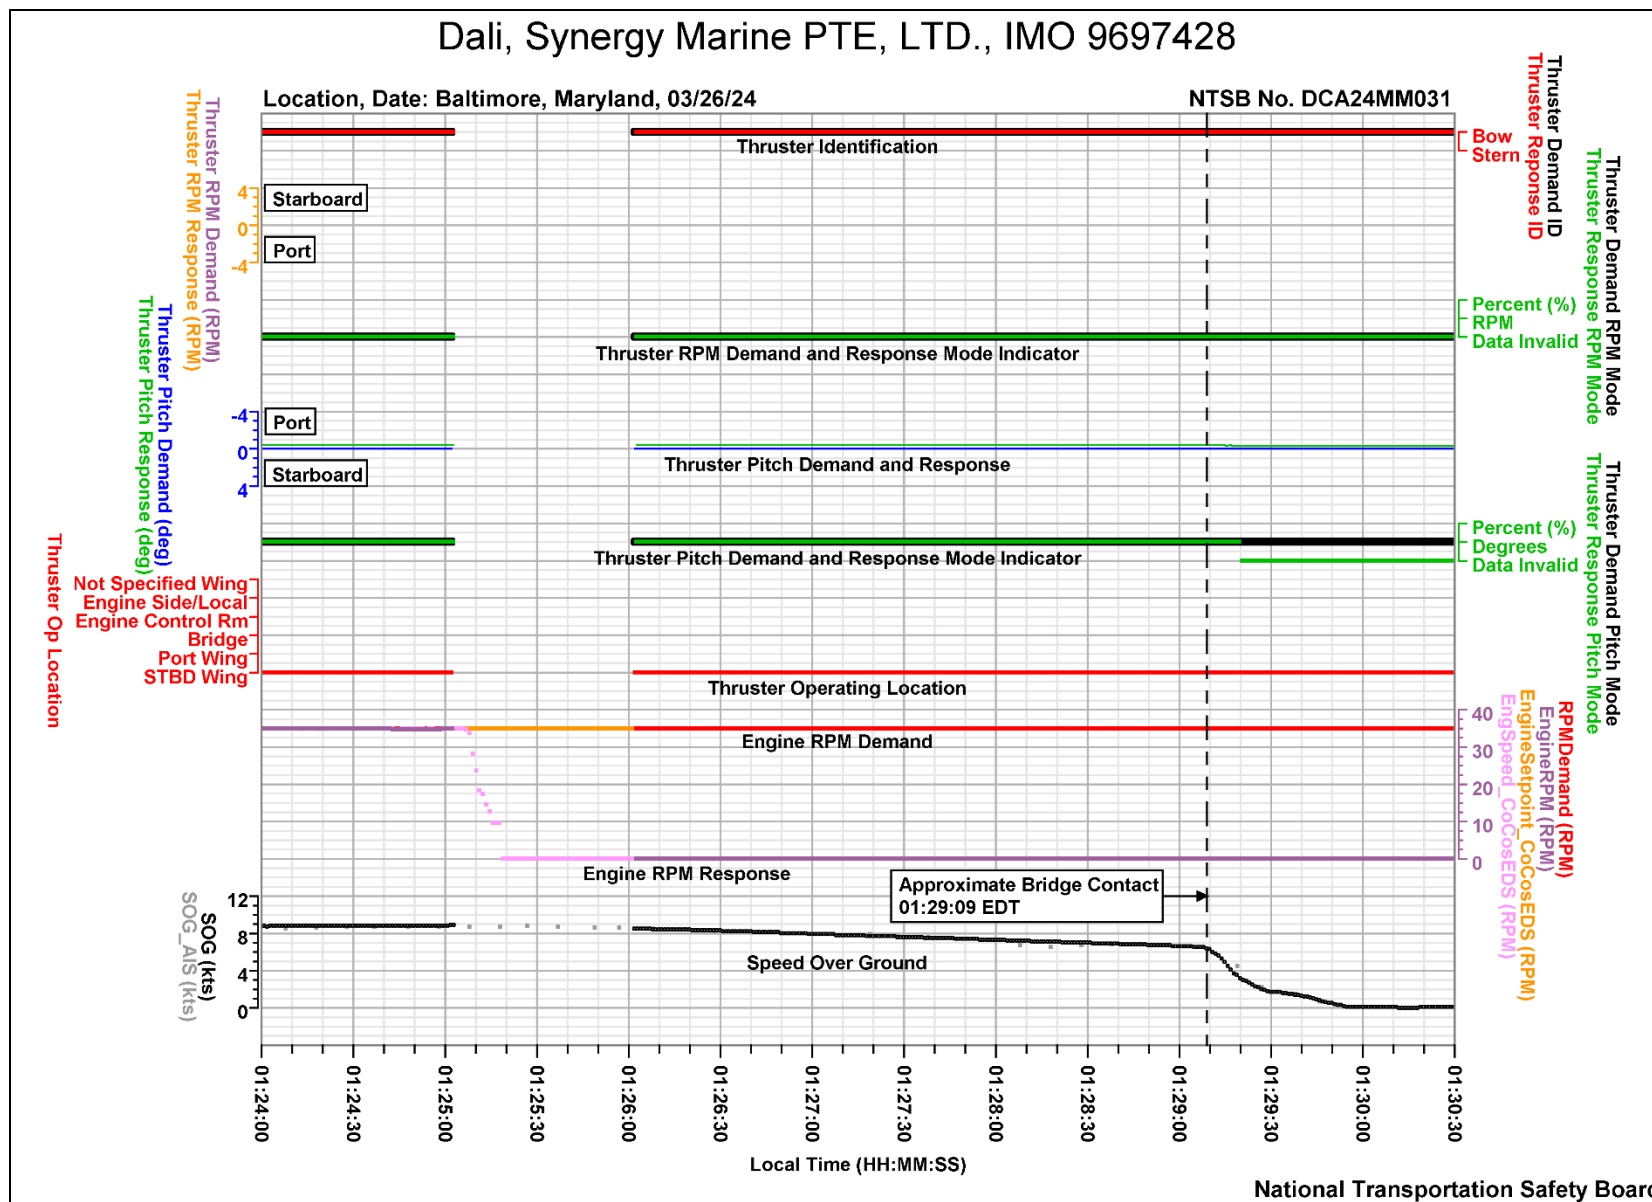
Figure 21. Thruster parameters recorded on the *Dali* for the time period 01:24:00 to 01:30:30 EDT on March 26, 2024.

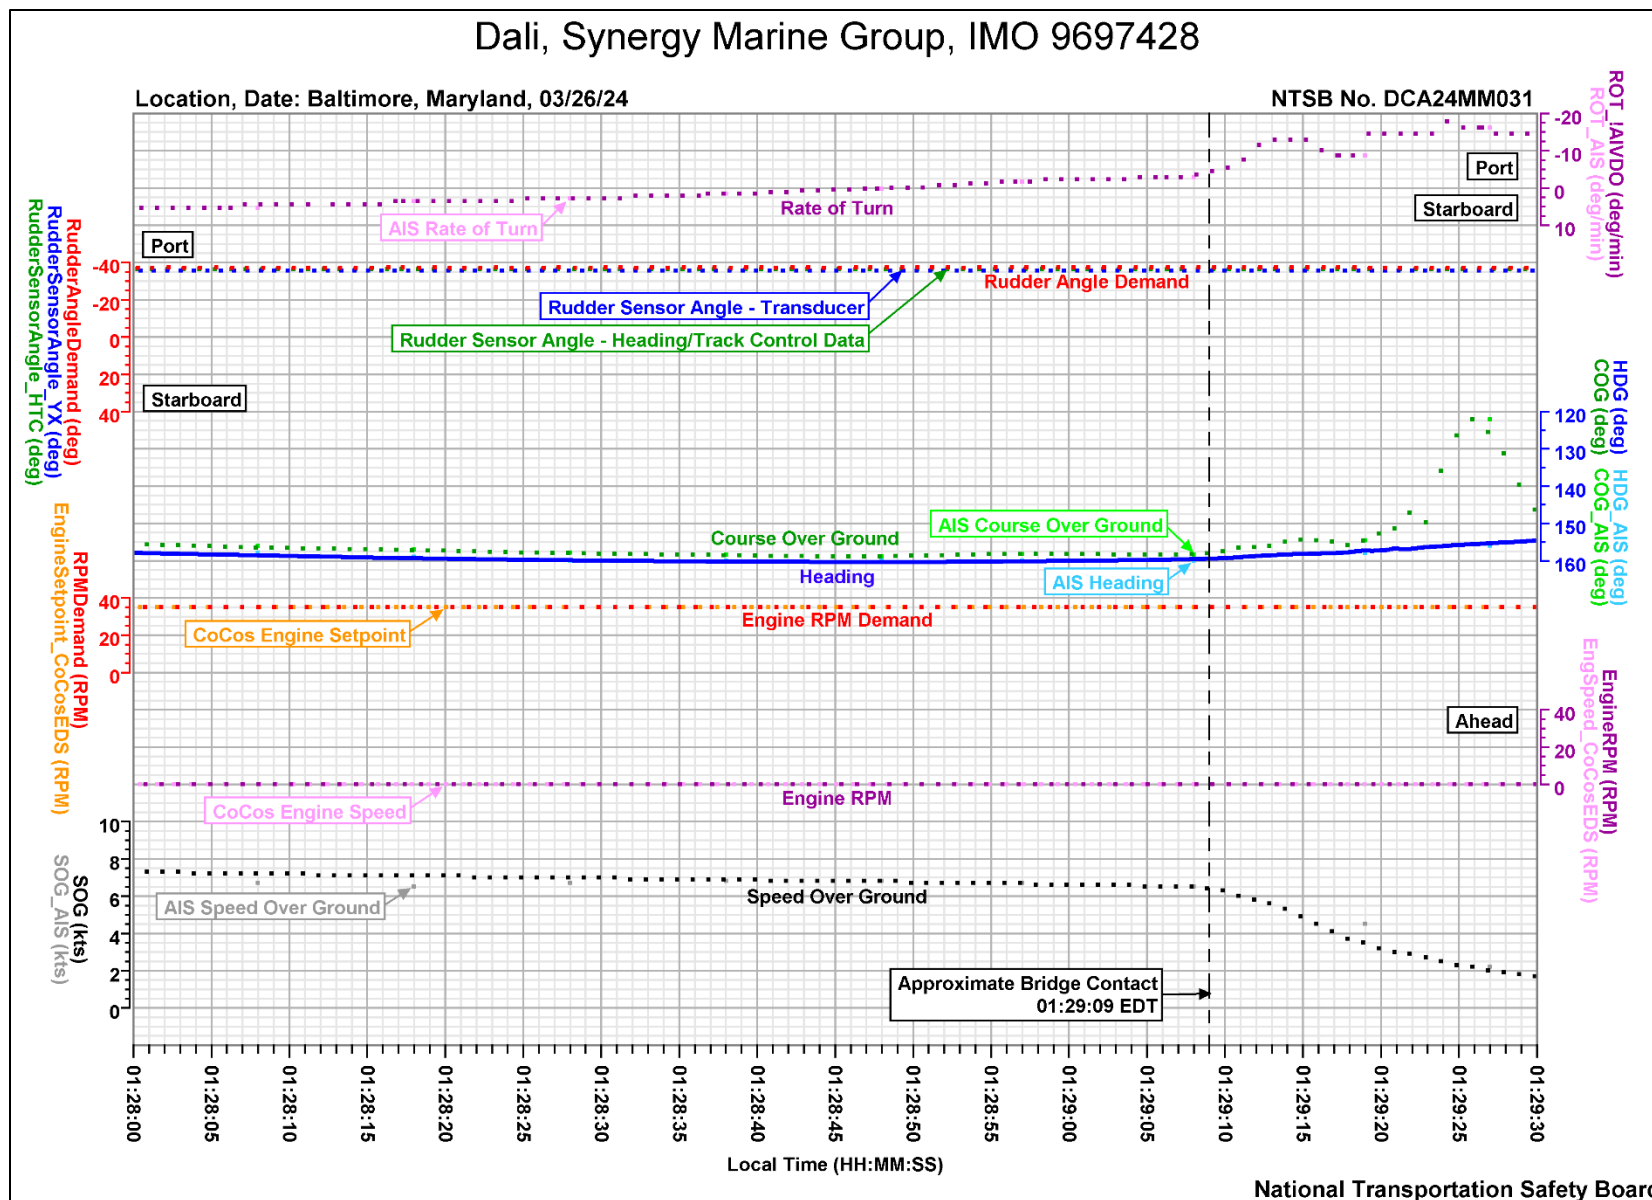
Figure 24. Recorded *Dali* parameters for the time period 01:28:00 to 01:29:30 EDT on March 26, 2024.

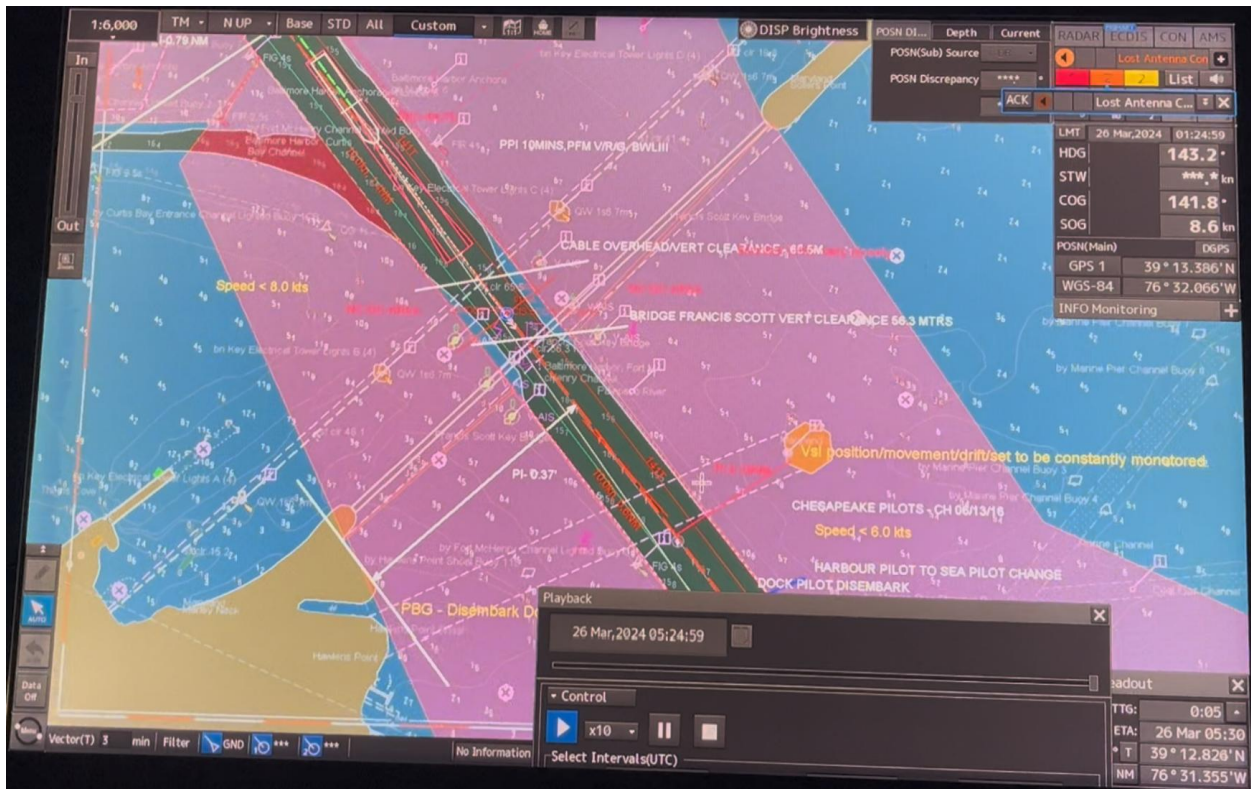
Figure 180. ECDIS playback image at approximately 01:25:53 EDT.

Figure 173 to Figure 180 contain additional ECDIS images captured during the ECDIS playback onboard the *Dali* from 01:24:51 EDT to 01:25:53 EDT - when ECDIS images were not recorded to the VDR. Figure 175 to Figure 180 show warnings of AC power failure and lost antenna control from approximately 01:25:11 EDT to 01:25:53 EDT.
