Near grounding of *Rosco Poplar*

Bond Reef, Hydrographers Passage, Queensland on 4 May 2022

ATSB Transport Safety Report

MO-2022-005

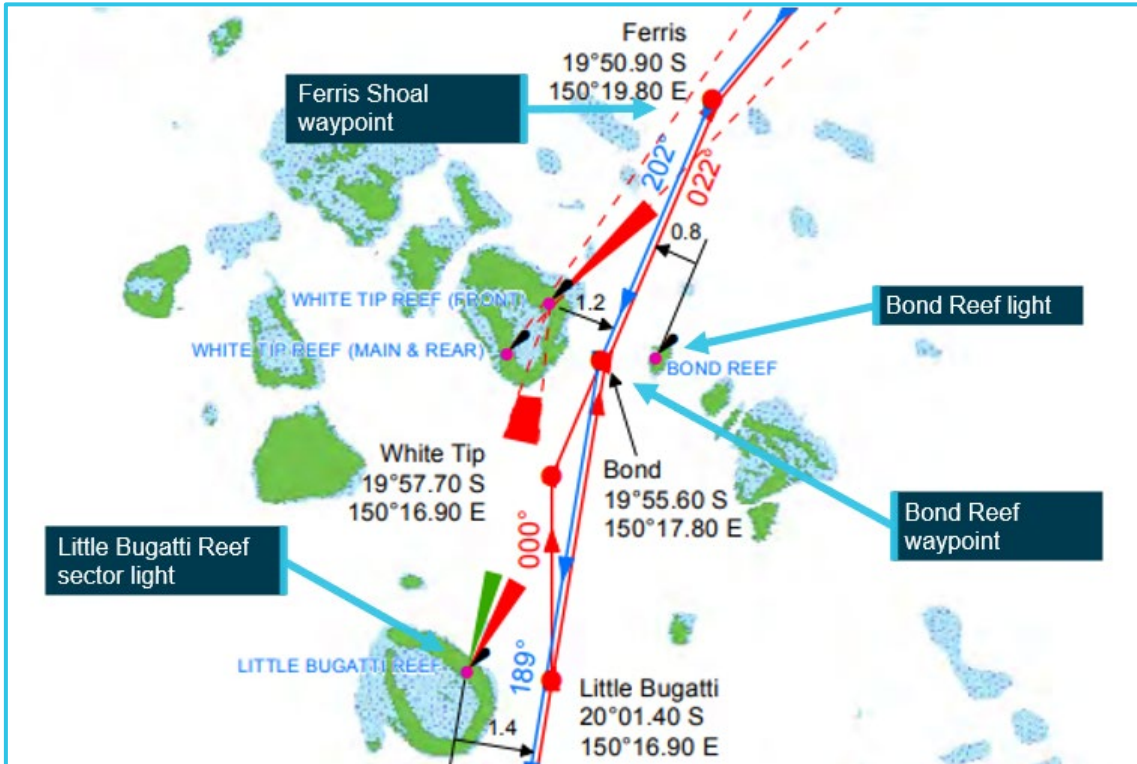
Figure 4: Standard planned routes near Bond Entrance (inbound tracks are blue)

As the ship passed the Ferris Shoal waypoint at 0246, the pilot ordered a 202° heading towards the next waypoint to track the ship 0.8 miles to the west of Bond Reef light beacon (Figure 4). According to the pilot, he saw that Little Bugatti Reef sector light was white at the time (the white and red sectors indicate safe and unsafe waters, respectively).

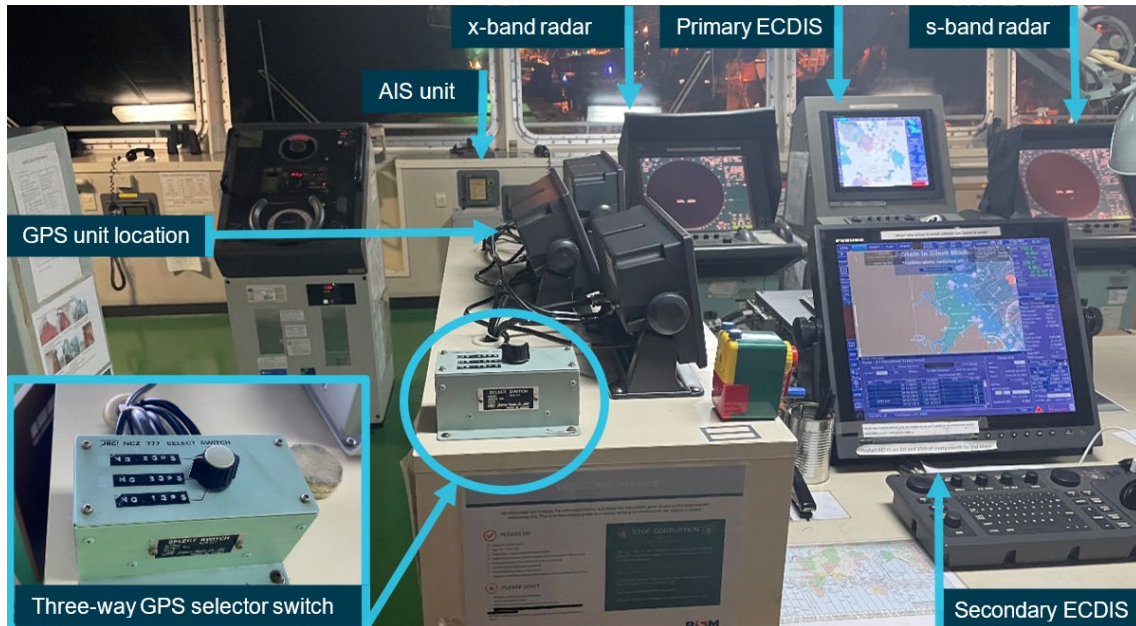
Figure 7: Rosco Poplar's navigational equipment bridge

Rosco Poplar was equipped with 2 Furuno EC3000 electronic chart display and information system (ECDIS) units. The primary unit was situated on the starboard side of the bridge, between the s-band and x-band radar units (Figure 7). The secondary ECDIS unit was fitted on the chart table behind the primary unit and radars. The automatic identification system (AIS) unit was located beneath the bridge window panels, forward of the primary ECDIS unit.

At the time of the occurrence, 2 Japan Radio Company (JRC) differential⁸ GPS units and a Furuno GPS unit were installed on the chart table near the secondary ECDIS unit. The data output feed from each GPS unit was connected to a 3-way selector switch, adjacent to the units (Figure 7 and Figure 8). A single output feed from the selector switch was connected via a JRC data buffer to a secondary buffer which distributed the data to the navigational equipment, including both ECDIS units, both radars, AIS unit and the voyage data recorder (VDR). The JRC JCY 1800 type VDR recorded bridge and communication audio, radar images and various other navigational data.

While in Australia, the ship's bridge navigational system was updated by shore technicians with new GPS units and a reconfigured wiring system to interconnect the electronic navigational aids. The update facilitated multiple GPS inputs for the different aids, providing greater redundancy in the event of single GPS unit failures.

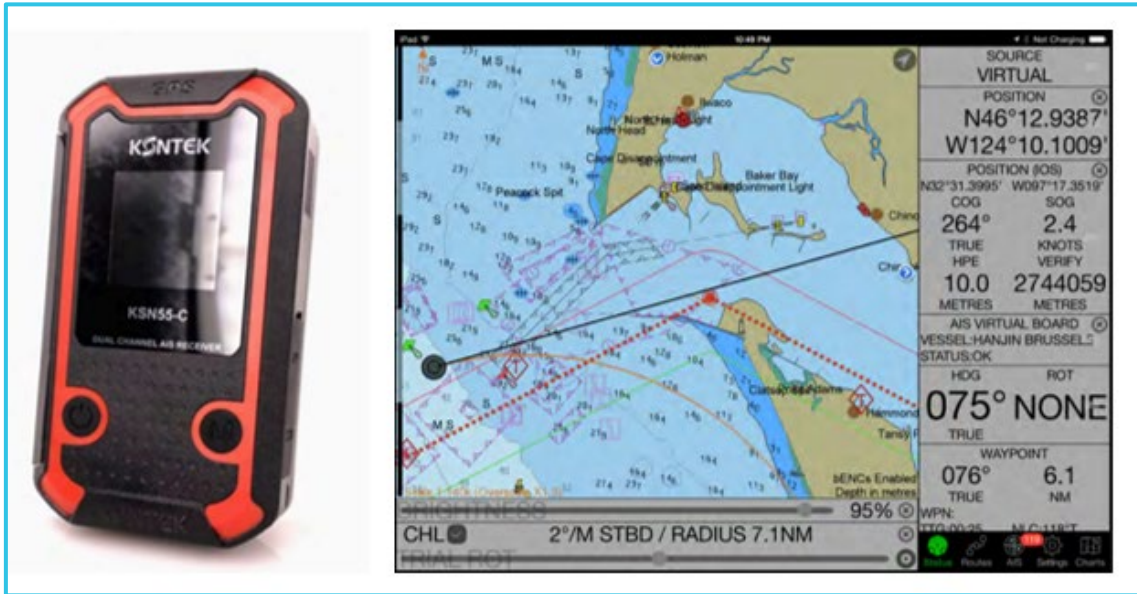
Figure 14: KSN55-C model PPU and example SEAIq chart display on a tablet device

The PPU used by the pilot at the time of the occurrence was a KSNTEK brand, model number KSN55-C (Figure 14). The unit was a dual-channel AIS receiver, with in-built GNSS and rate of turn (ROT) capability. The unit could operate independently or be connected to the ship's navigational systems via the pilot plug. The unit displayed position, speed, course, heading and ROT information on its own LCD screen and was also capable of displaying that information on a tablet or computer device equipped with electronic navigational charts (ENC). Auriga provided its pilots with tablet devices and SEAiQ Pilot software.²⁴
