MARITIME SAFETY COMMITTEE 109th session Agenda item 13

MSC 109/13/3 26 September 2024 Original: ENGLISH Pre-session public release: ⊠

Ineffectiveness of the radar SART

Submitted by the United States

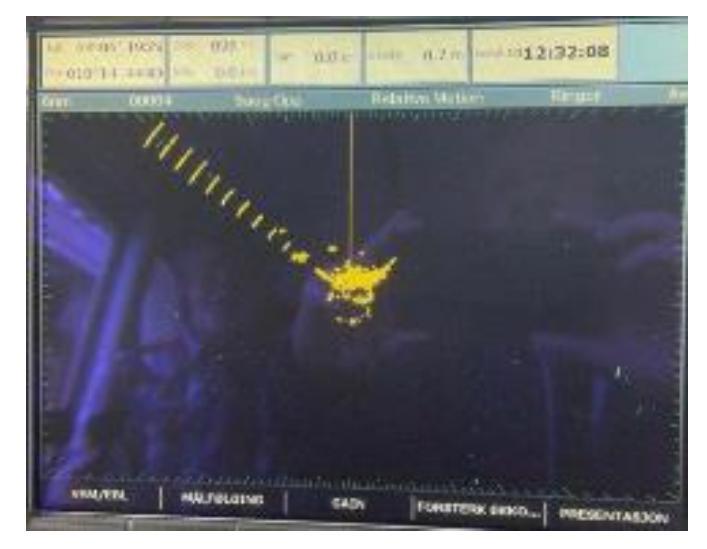
SEACOR's radar SART display when radar was properly set to SART mode. None of the vessels involved in the search for survivors received this radar SART signal²

2.2 The radar operator's manual should be consulted on necessary settings for displaying radar SART signals. These settings typically change range settings and detune the radar out of its best tuning condition, erasing or weakening all normal radar echoes. For this reason, radars should only be set to display radar SART signals when not immediately needed for navigation or target detection.
